## Axle Oil leakage

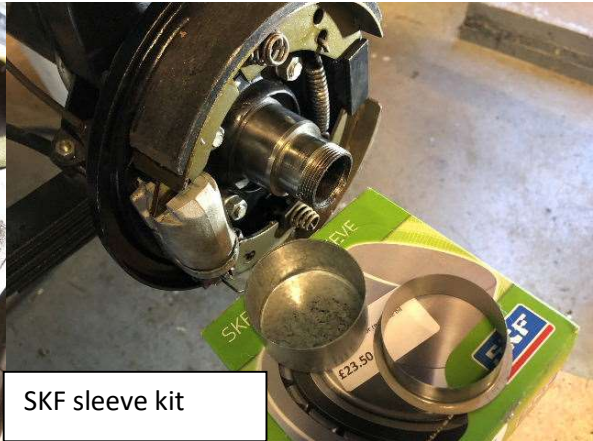
The sleeve comes as a plain ring with an application collar at one end. The collar can be removed when fitted as there is a groove around the circumference which is weakened in readiness. There is also a specially sized ‘cup’ which is intended to be used to slide the sleeve into position. However, due to the threaded projection which holds the large nut, this is of no use in this process – so it can go in the bin.

SKF sleeve kit

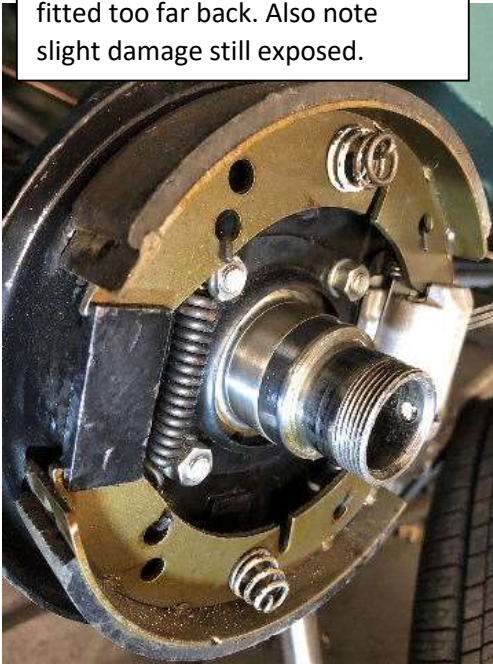
Now there is a problem at this point which I only realised after I had fitted the sleeve and discovered it was in the wrong place – thereby wasting the part as it cannot be removed without wrecking it. As the supplied ‘cup’ was of no use to install the sleeve, I put the hub back on as it is ideally sized to push the rim along the axle into position. When I had pushed the sleeve right back as far as it would go – it dawned that the new oil seal running surface was not in the correct position as it had been pushed right back beyond the reach of the seal which is quite close to the outer shoulder on the axle. The only answer was to fit a second sleeve(!) and trim it to fit the bearing shoulder. I made the expensive mistake so you don’t have to.

This shows the sleeve incorrectly fitted too far back. Also note slight damage still exposed.

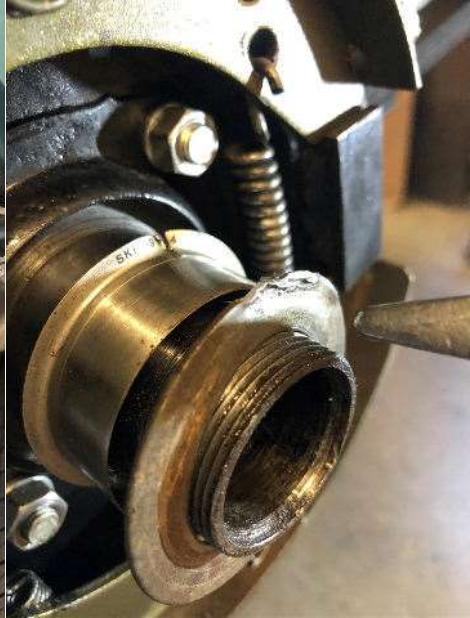
This shows the sleeve on the other side being fitted using an old locking washer to gently ease it over the axle.

I had decided to treat both sides – as I believe that it is better to keep things even – and so this gave the opportunity to try and get it right the second time. I ‘snipped’ the fitting collar prior to fitting so that it could be easily removed afterwards. You just have to be careful to just push the sleeve far enough along the axle so that it is flush with the shoulder – and no further.
