FRONT SUSPENSION OVERHAUL

Words and Pics Brian Wood

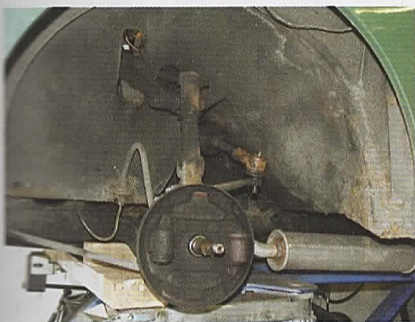
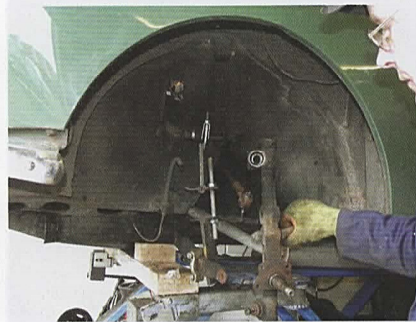
I used my patented suspension clamp as shown in the photo. The trunnions should be removed, cleaned and refitted. It is a bit easier to inspect them (and the threads on the leg) if they are clean. As already mentioned there is usually a tiny bit of play. A bit more than 'tiny' and you will need new trunnions. If there is still too much movement with new trunnions it means that the steering legs themselves will be unserviceable and need replacing.

As ever - good luck with your spanners and if anyone would like the dimensions of the suspension clamp - let me know via Russ and I'll send you a drawing (or even make you one for a small fee!) Incidentally the lower 'U' clamp has since been replaced by a welded bolt which goes through one of the holes in the lower arm - avoiding the possibility of slippage! ■

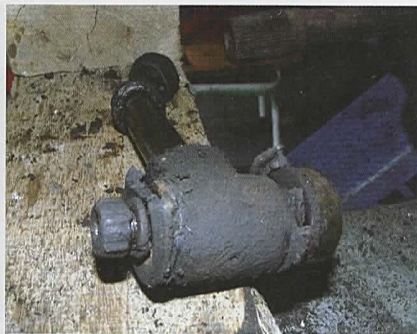
The corroded top pin shown in the photo was an absolute 'pig' to remove from the damper arm. I tried the old trick of simultaneous bashing the arm and the pin in opposite directions to 'shock' open the tapering joint. Having failed to achieve more than a completely crippled thread at the front and a less than polite personal demeanour, I resorted to the oxy-acetylene set to apply a bit of heat. This was ultimately successful and resulted in the separation of components.

However, I didn't notice until afterwards that I had inadvertently bent the damper arm slightly backwards. This had resulted in a mysterious backward 'twist' to the whole steering leg assembly which is actually noticeable in the photos of the back plate and wouldn't have done much for the handling! Luckily I had a spare r/s shock absorber which had to be fitted. This serves to reinforce the view that brute force and ignorance should be used with due discretion! I have since learnt that the correct procedure is to wallop the outside of the 'eye'. This technique, if applied to any taper joint should result in the pin popping out like a cork from a bottle (according to Roy –of "Roy's Welding" – Thanks)

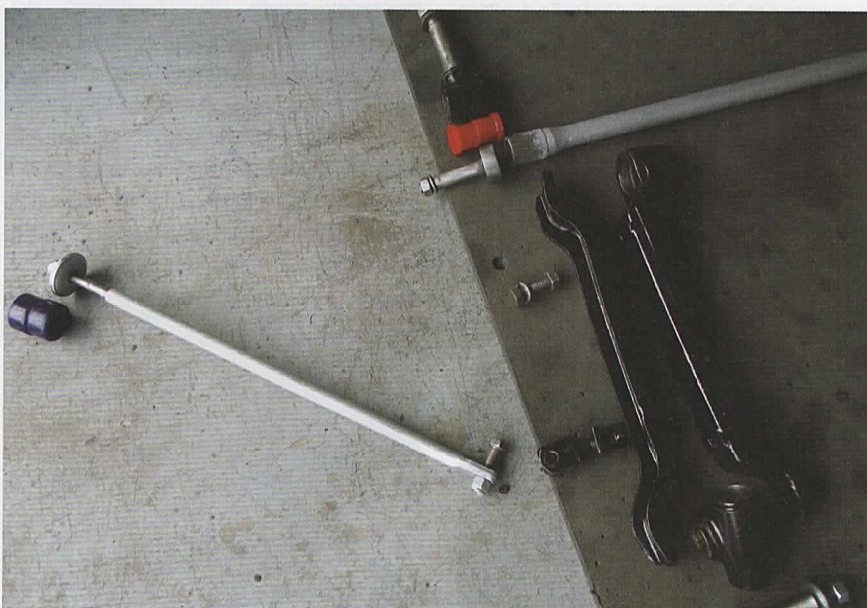
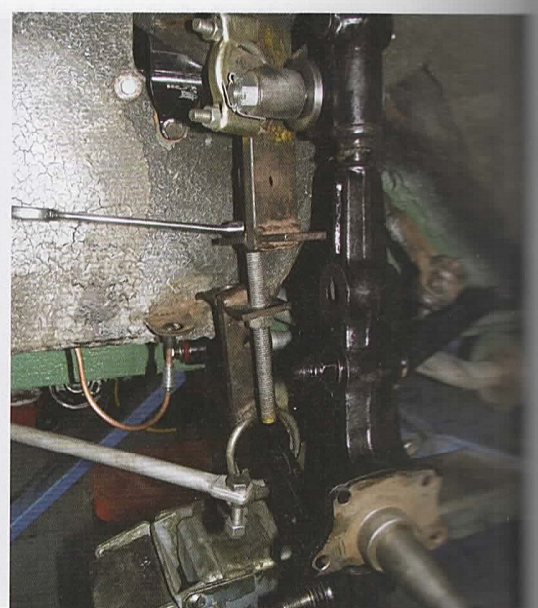
New wheel bearings were fitted into the hubs I had decided to fit a set of polypropylene bushes which are available for about £20. These are better quality than the standard rubber

ones and should last longer. If you are particularly sensitive, you might notice a slightly 'harder' ride.

The recommended procedure for fitting these is to apply a little washing up soap so that they slide in easily. Excess lubrication (i.e grease) should be avoided since you don't want the bushes turning inside their housings when in service. They should be fitted loosely and the securing nuts only tightened when the suspension has its working load applied.

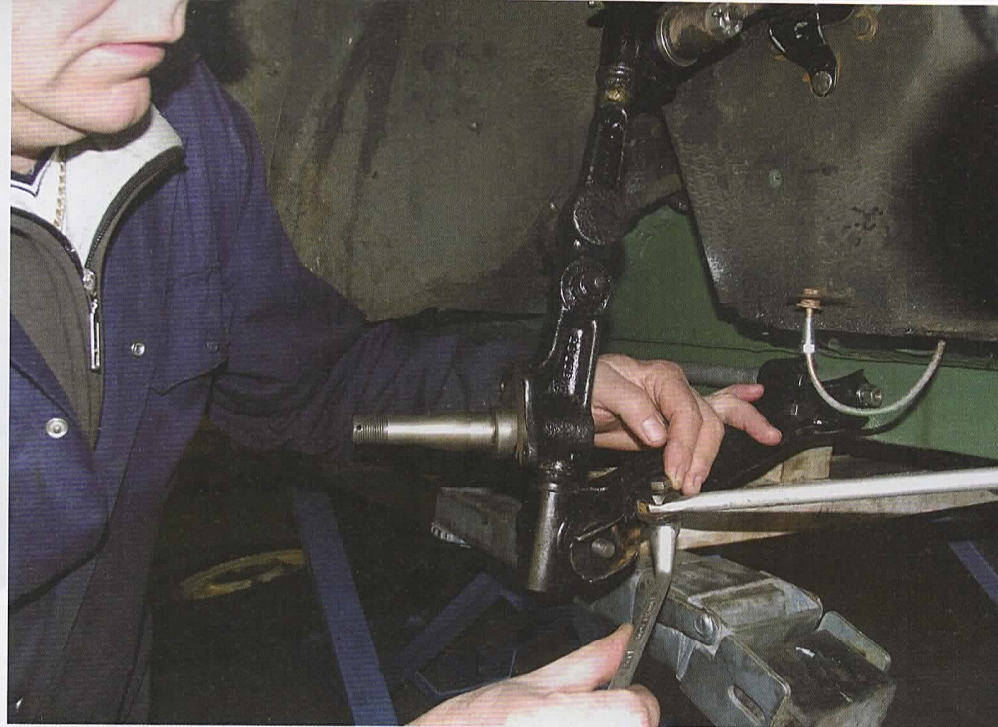
Refit the cast lower suspension arm loosely on the torsion bar and re-fit the front end assembly (with eyebolt) into the chassis leg. The lower arm should be rotated around on the splines until you have 432mm (+/- 6mm) or 17" (give or take 1/4") distance between the bottom of the circular hole in the inner wing (on the outside of the shock absorbers) and the centre of the lower pivot at the end of the suspension arm. This tip has been used by me several times and trust me, it works! The only time it didn't work was on a car where the owner had welded steel plate over the holes in the inner wing and removed all trace of them! You can use the vernier adjuster on the cross member to fine-tune the distance if necessary. If it is a little over the specified distance on the driver's

side, I think this is OK since this helps to achieve an even keel. It is sometimes difficult to replace the tie bar and to get the bolt at the lower arm end into place so I always try to assemble it in conjunction with the lower arm when it is all a bit loose. You can then tighten up the nut at the front (on the chassis leg bracket) to put sufficient tension in it afterwards.

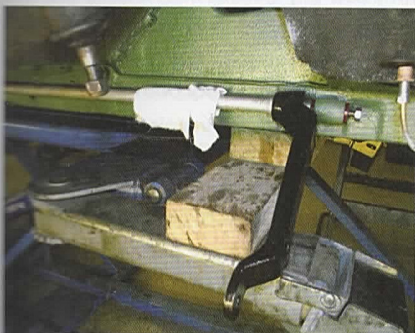
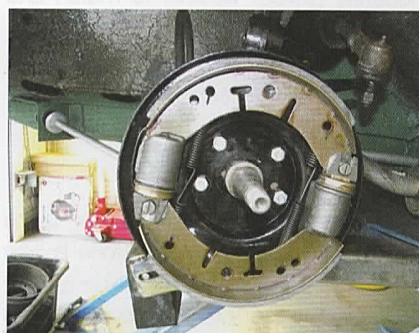
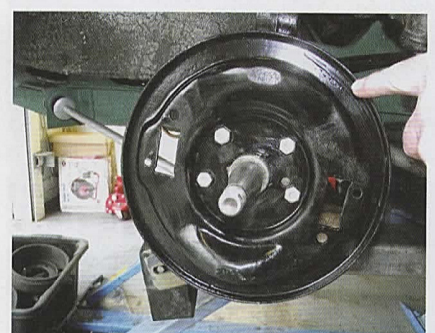
be able to see the 'LH'/'RH' markings as indicated by my finger in the photo. If the marks are not visible, check that the brake cylinders are pushing against the direction of rotation of the hub. The braking system is designed as 'twin leading shoe' and if you get it wrong you will have 'twin trailing shoe'. This, you will find, will give you excellent braking performance, but only in reverse gear, however.
